# SUBMERSIBLE ELECTRIC PUMPS

PUMP STATION INSPECTIONS SAVE MONEY & PROPERTY

CAST IRON PUMP VS. MWI 316SS PUMP

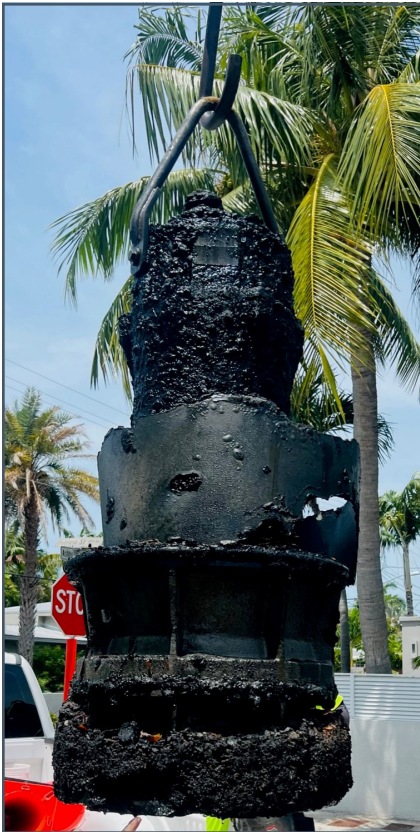
## CAST IRON PUMP

**3 YEARS:  
REQUIRED  
REPLACEMENT**

During recent pump station inspections in South Florida, the comparison between a cast iron submersible electric and MWI's 316 stainless steel submersible electric pump highlighted significant differences. The pump to the left was removed due to failure after just over 3 years of use. The need for replacement resulted in unexpected downtime and non-budgeted costs.

### CAST IRON PUMP ISSUES

- Heavy corrosion on the motor housing
- Discharge diffuser detached from the pump with multiple holes rotted through
- Impeller blades missing

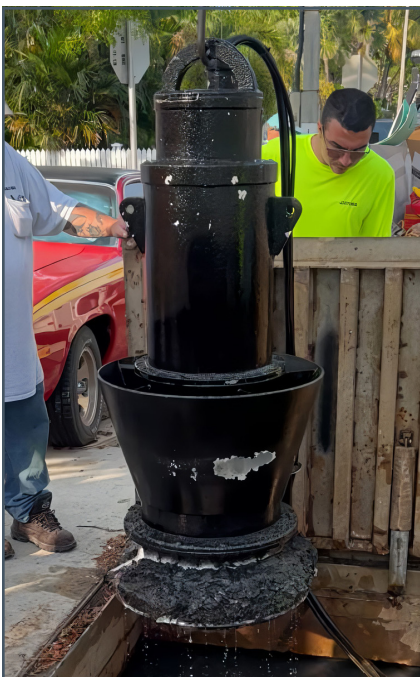
## MWI 316 STAINLESS STEEL PUMP

**5 YEARS:  
GOING STRONG**

### MWI STAINLESS STEEL PUMP

- Complete 316 stainless steel construction
- No corrosion or growth on the housings
- Placed back into service after a clean bill of health
